**Suspected Illegal Sewage Discharge Spotted in the “Revitalisation Zone” of
Tung Chung River Park**

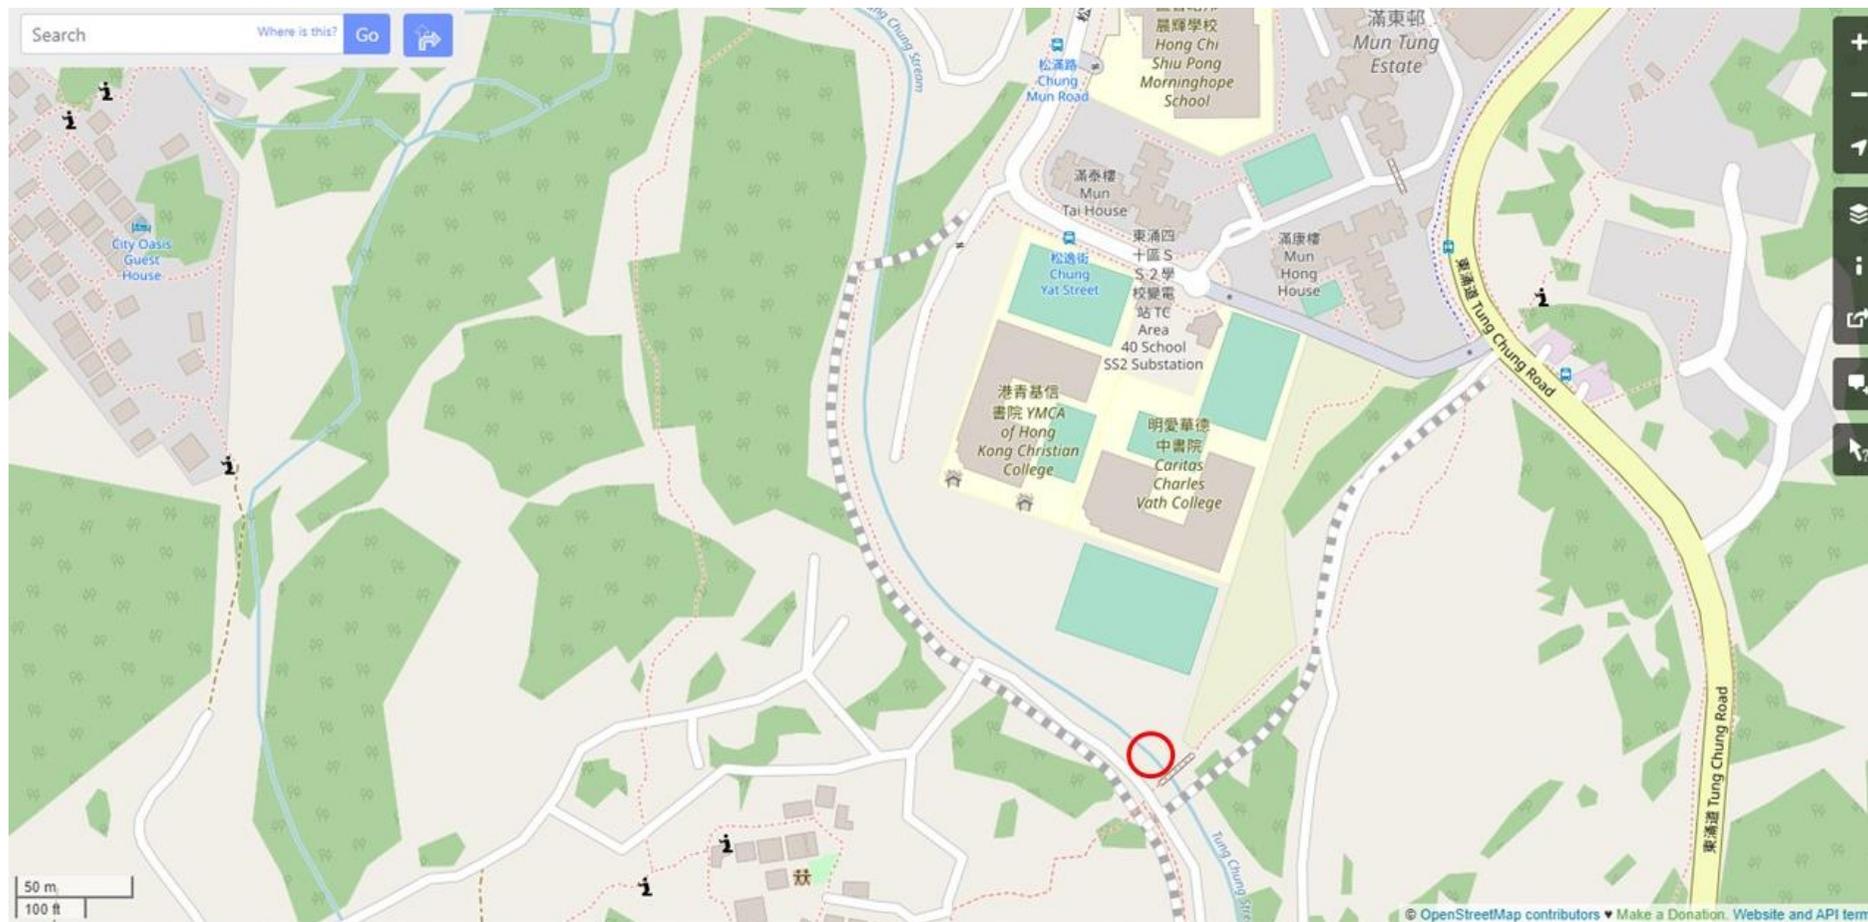
Figure 1. Location (denoted by red circle) of a storm drain outlet with suspected illegal sewage discharge sighted on 15th January, 2022.

1. What is the catchment area of the storm drain concerned (see Figures 1 & 2)? Does this catchment area include Mun Tung Estate and Area 42 (currently a worksite undergoing land formation for Residential (Group A))?

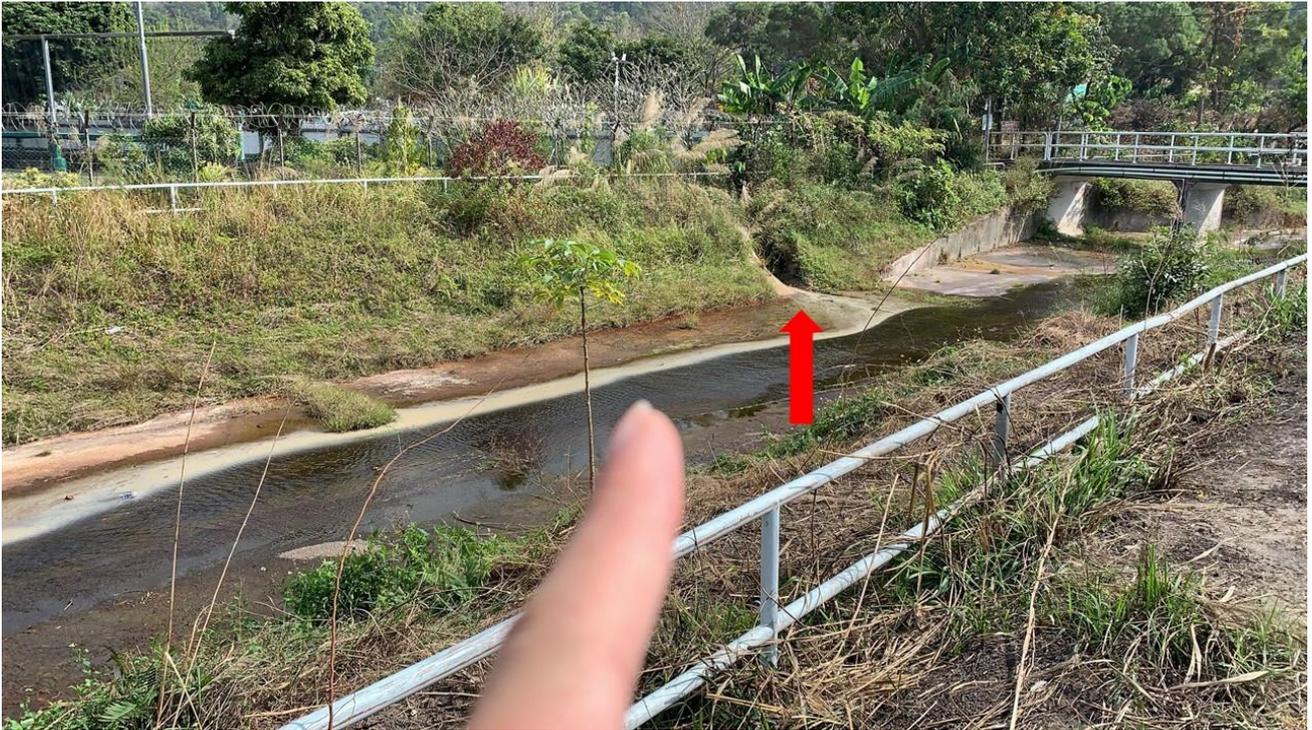
Green Power visited Tung Chung River, Lantau on 15th January, 2022 and spotted discharge of a large amount of murky white sewage at around 12:00 noon through a storm drain outlet (Figures 1 & 2) into the channelised section of Tung Chung River East Stream, which is currently included as the worksite of the Tung Chung River Park “Revitalisation Zone” (Figures 2 & 3). The quantity of sewage was so large that it rendered the water at the sections downstream near the estuary milky white (Figures 4 & 5). The discharge continued for at least an hour.

Figure 2. Storm drain outlet (denoted by red arrow) with suspected illegal sewage discharge sighted. Photo taken on 15th January, 2022.

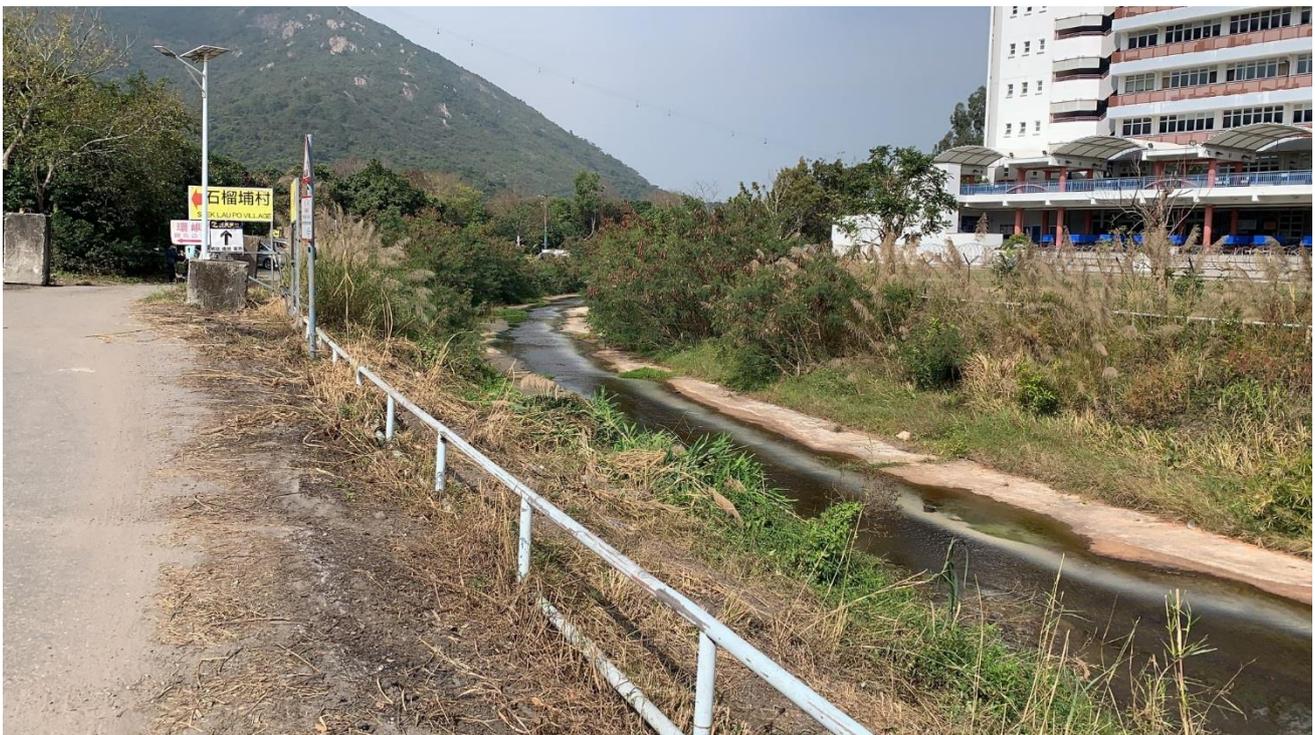
Figure 3. Stream of milky white sewage running through the channelised section of Tung Chung River East Stream. Photo taken on 15th January, 2022.

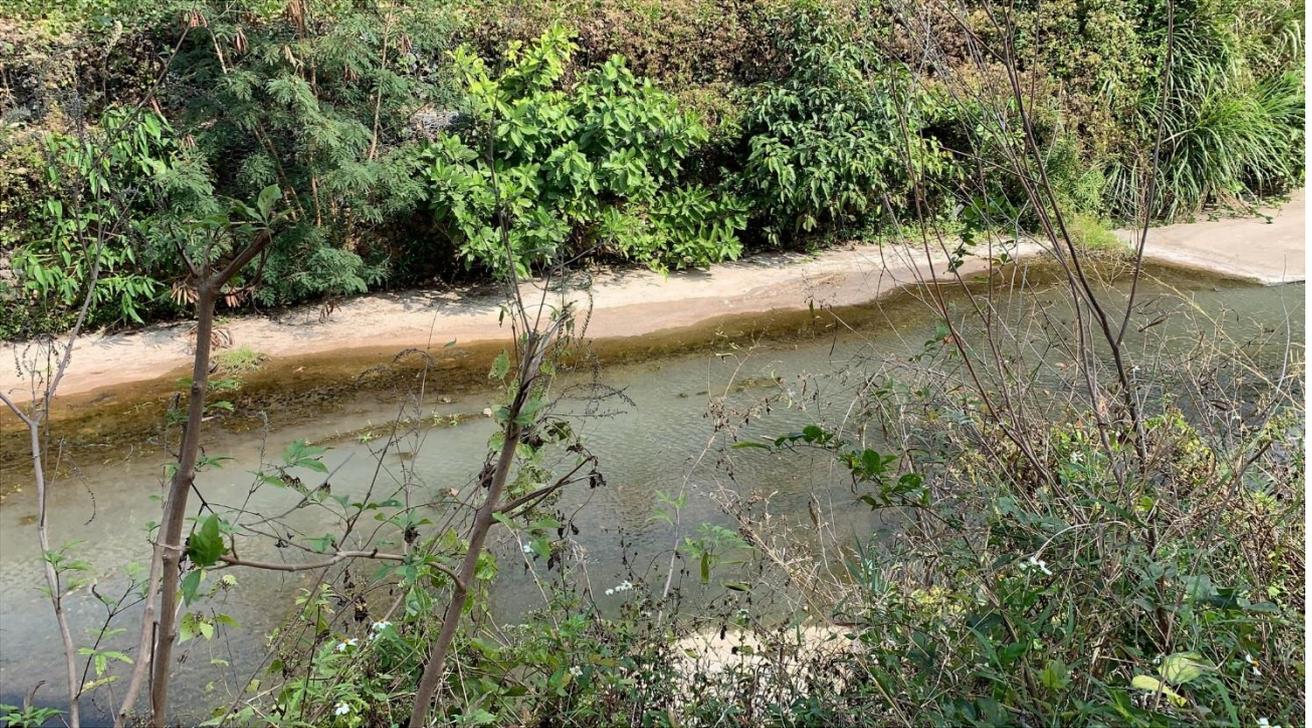
Figure 4. Lower channelised section found to be filled with milky white sewage. Photo taken on 15th January, 2022.

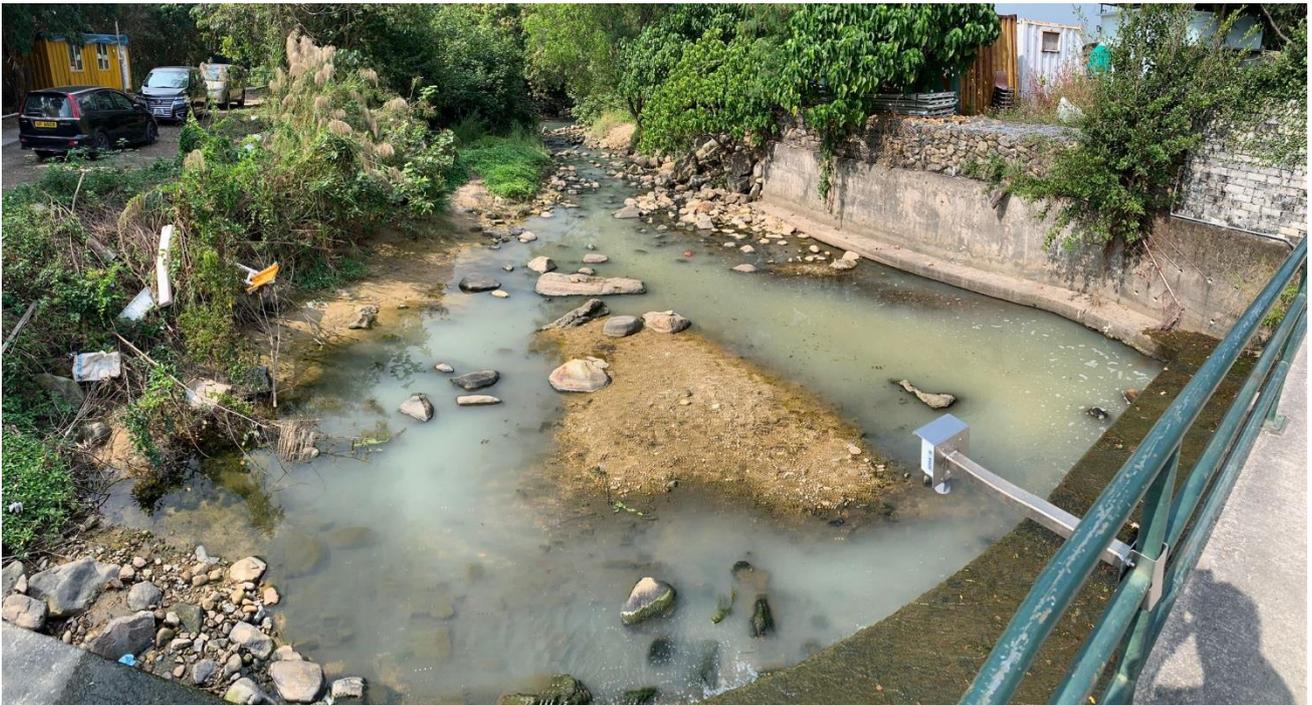
Figure 5. The natural section near the junction of Tung Chung River East and West Streams were found to be filled with milky white sewage. Photo taken on 15th January, 2022.
